MISCELLANEOUS PAPER GL-87-29

# CONDITION SURVEY AND PAVER IMPLEMENTATION MACDILL AIR FORCE BASE, FLORIDA

November 1987

Final Report

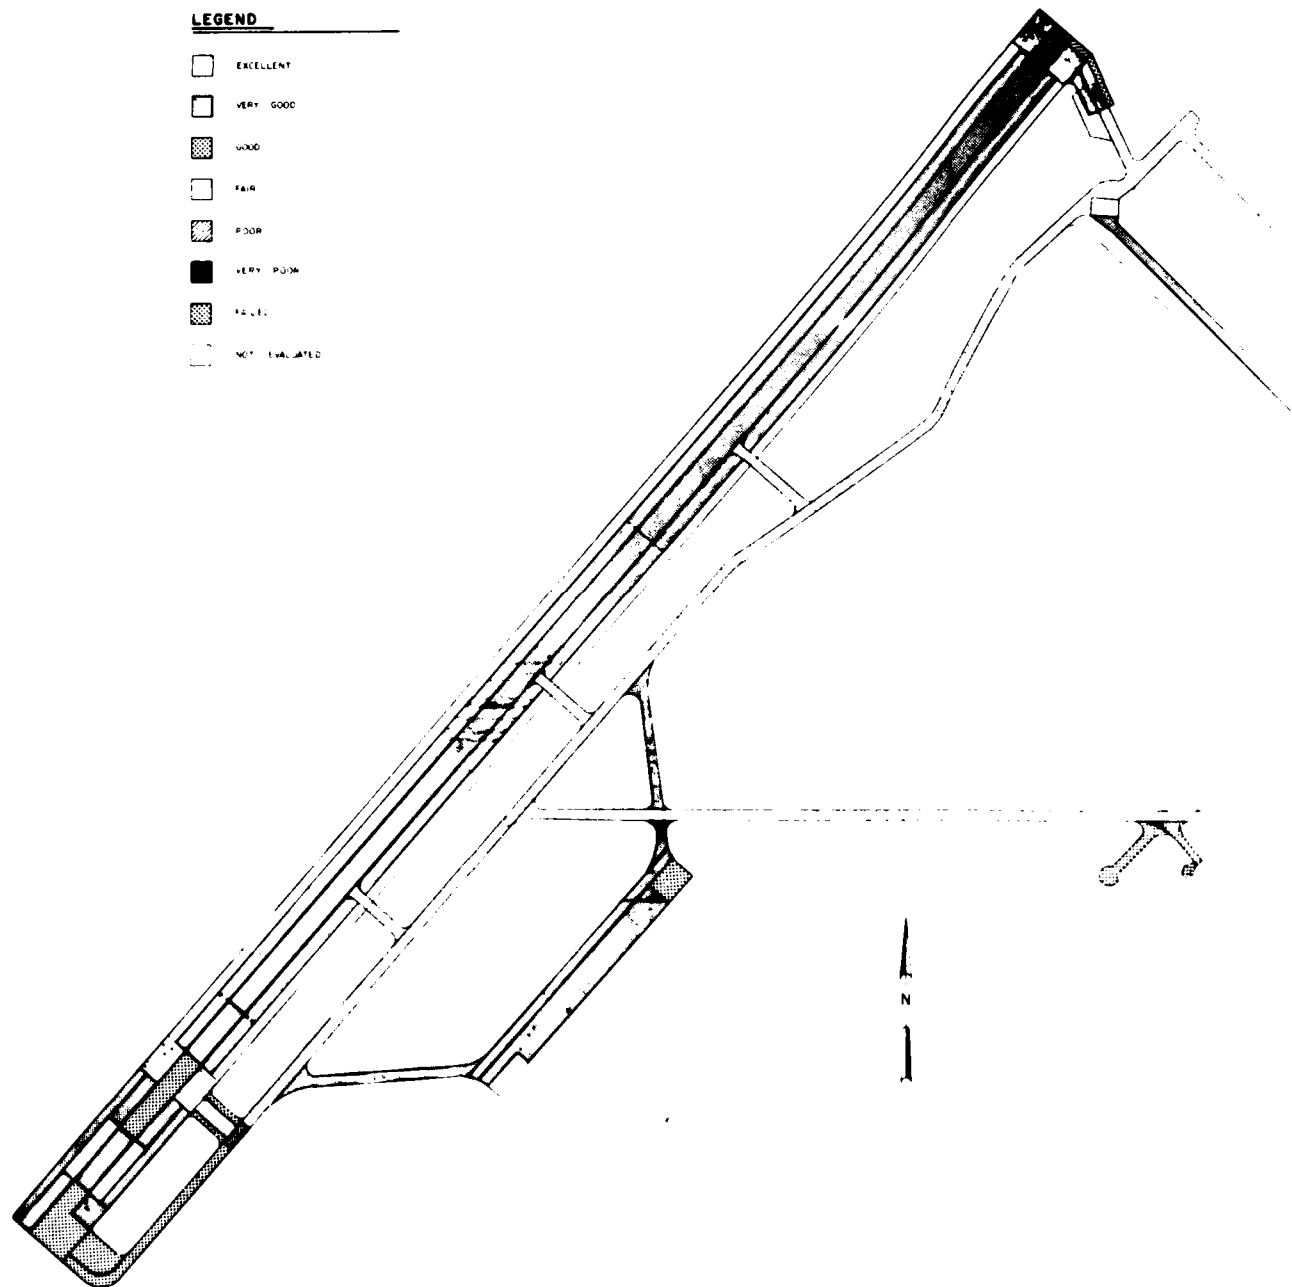
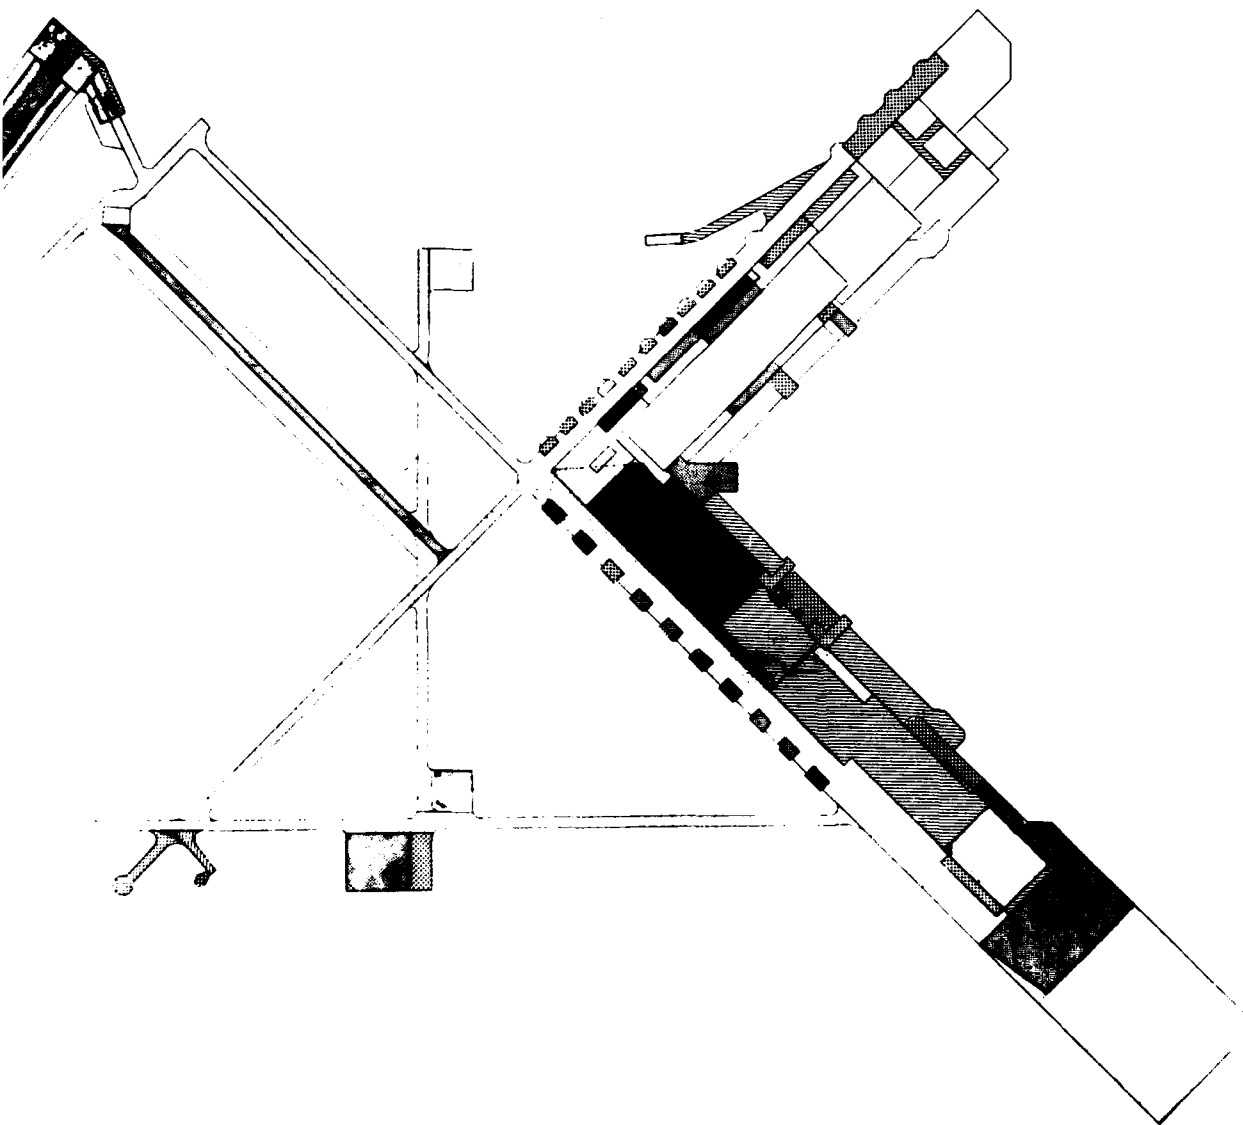
Figure 53. Pavement condition

12. The majority of the pavement features at MacDill AFB are rated from fair to excellent condition with some features rated poor to failed. Figure 53 illustrates the condition ratings of the features at MacDill AFB, and Table 2 describes the more prominent distresses observed in the features. Photos 1 through 19 show various distresses that were observed on the airfield pavements.

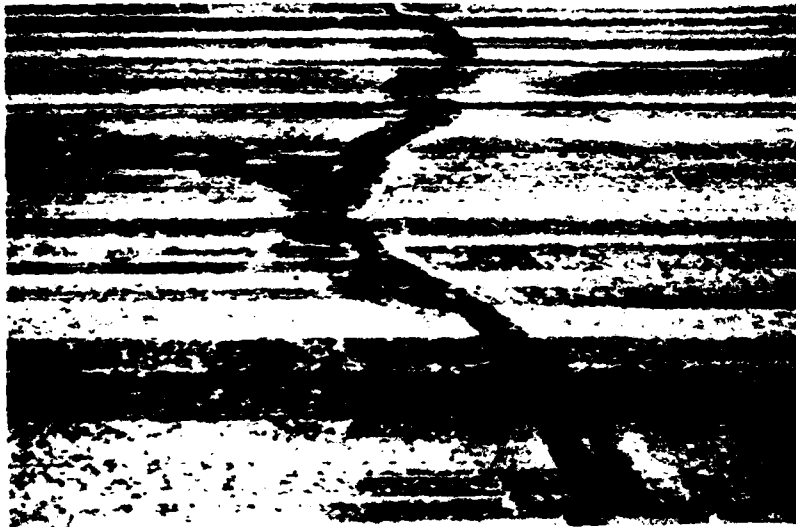
Photo 1. Medium severity cracking in PCC,  
Runway 4-22 (R3B)

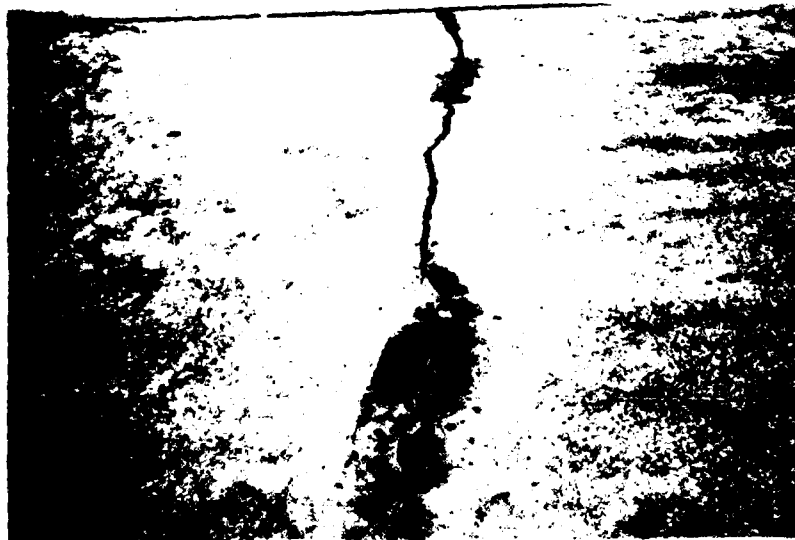
Photo 2. Sealed, low severity crack, Runway 4-22  
(R5B)

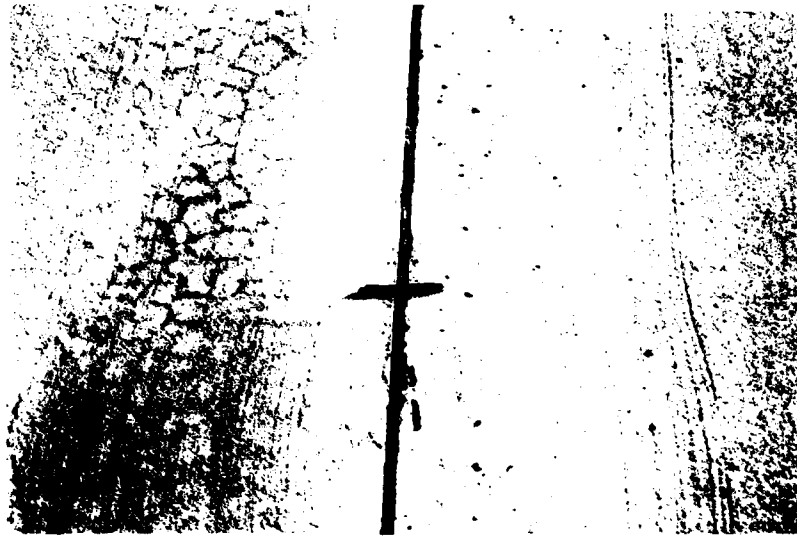
Photo 3. Typical joint seal damage, allowing incompressibles into the joint, Runway 4-22

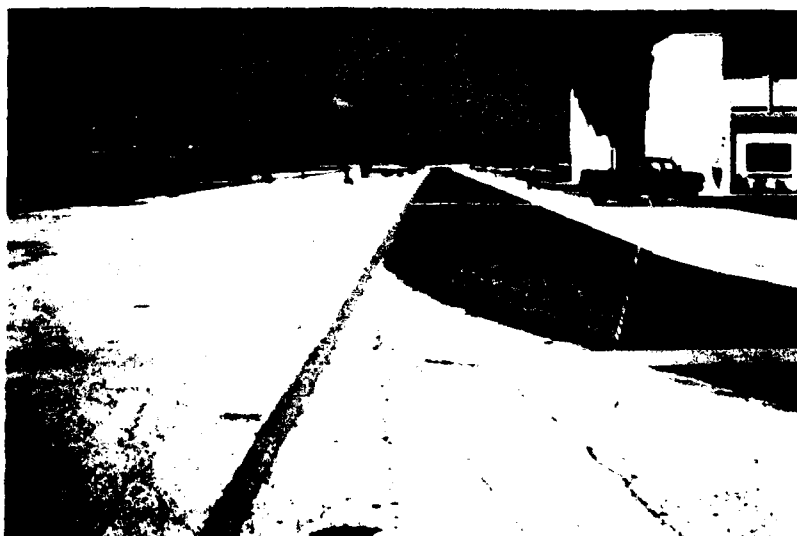
Photo 14. Shoulder pavement being used for apron,  
aircraft fuel cell repair and corrosion control  
apron (Note airplanes to left of picture)

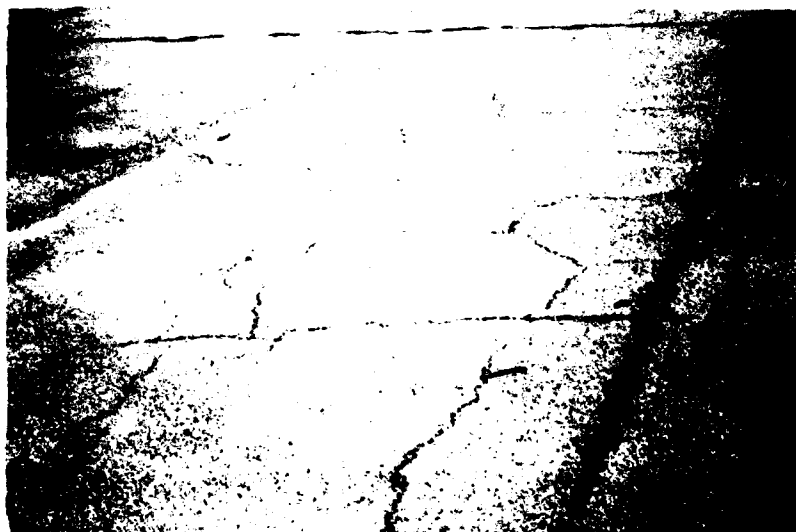
Photo 19. High severity joint reflection cracking  
and medium severity block cracking, south ramp
